OLD WORLD CRAFTSMANSHIP MEETS NEW WORLD TECHNOLOGY

The Restoration of the Historic Schinasi Mansion

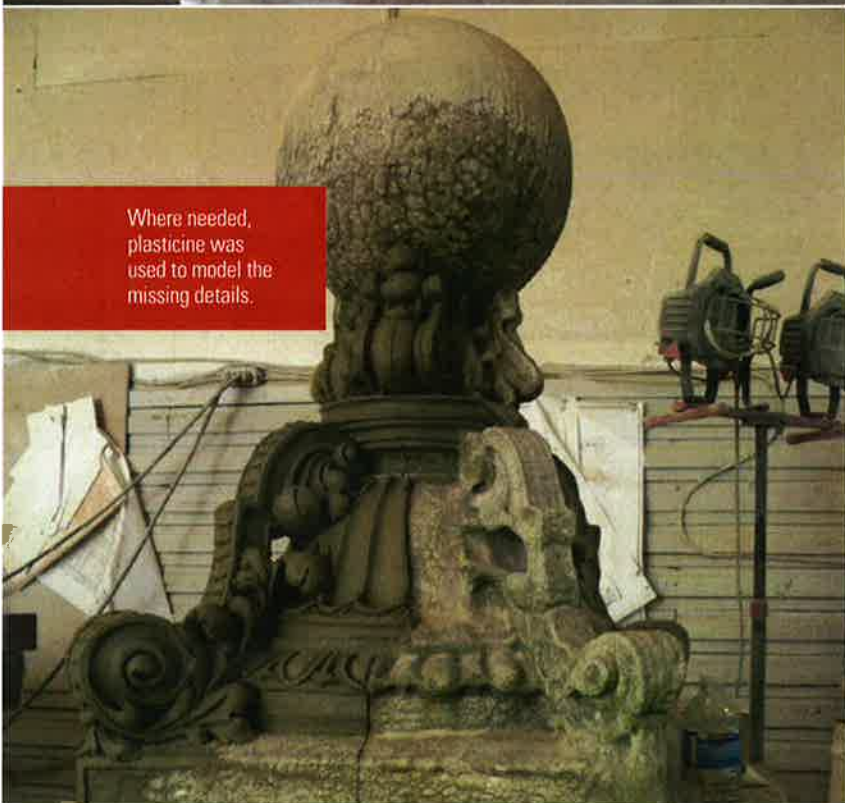
Where needed, plasticine was used to model the missing details.

Samples of carved units were selected on site, removed from their assemblies and shipped to the carving shop. French Renaissance Revival architectural detail is not in everyone's vocabulary, and the architect was first to admit that he was not that familiar with the shapes and profiles of the highly ornate features. He relied on the expertise of others to interpret the existing remains and used plasticine to modeling the missing details. The entourage, including representatives from the architect, project manager, and masonry contractor, arrived to review the modelling work and approve the concept. Progress photos submitted via the Internet

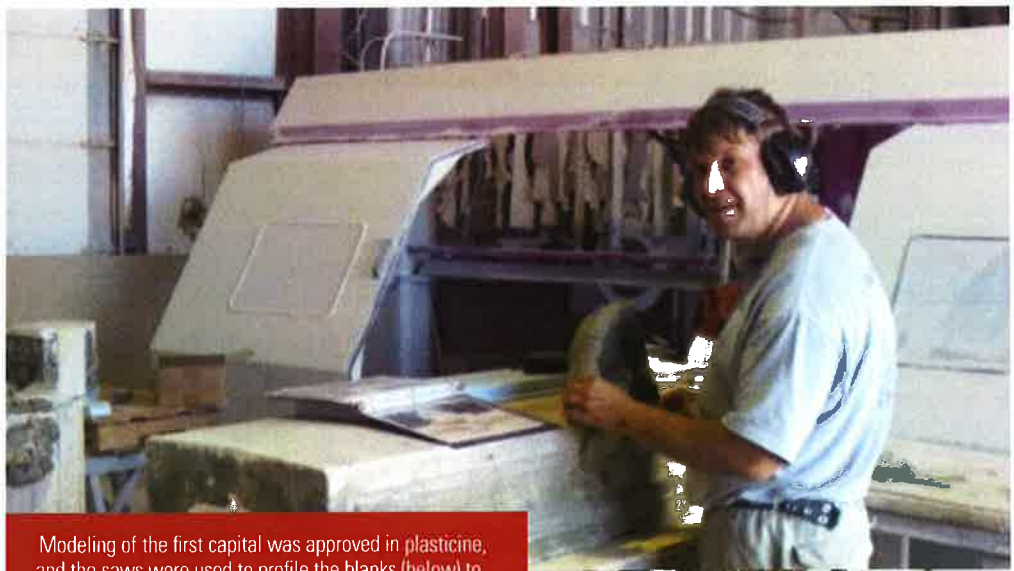
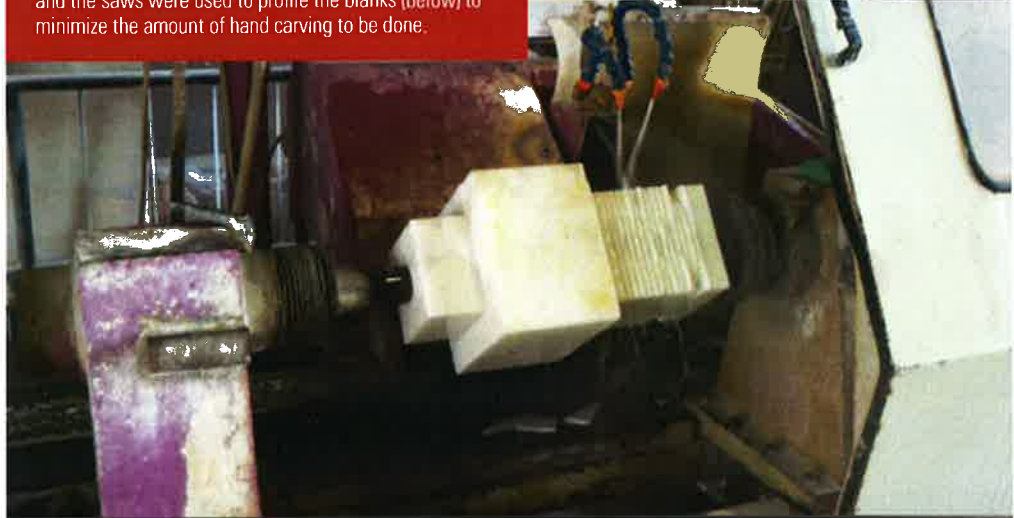
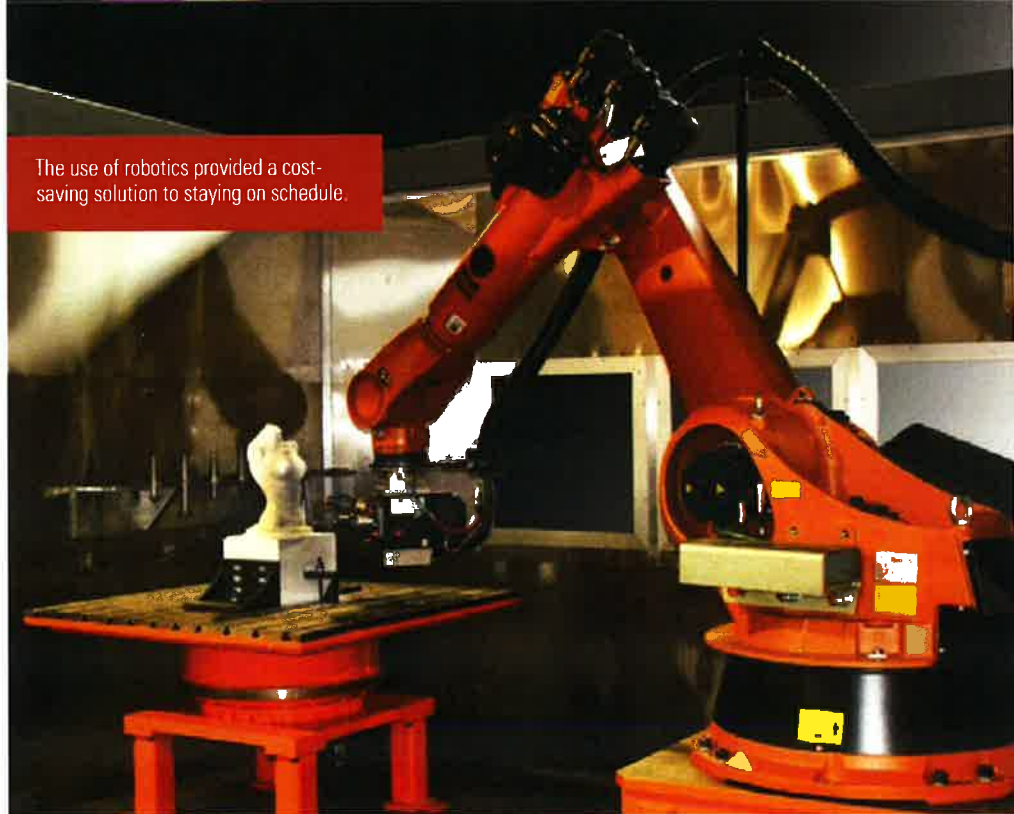
Modeling of the first capital was approved in plasticine, and the saws were used to profile the blanks (below) to minimize the amount of hand carving to be done.

Sculptors and carvers capable of producing such work in marble are few and far between in North America. When it came to producing 23 carved pilaster capitals, there was not sufficient time in the schedule and talent in the carving shop to meet the demand. Modeling of the first capital was approved in plasticine, and the saws set about profiling the blanks to minimize the amount of hand carving to be done. The master marble pilaster capital was sculpted, and six carvers set about copying the new master sample. Progress was slow, and the deadline for dismantling the scaffold from the site loomed. "Delay of contract" was a constant reminder. In a brief moment of inspiration and desperation, contact was made with a local robotics repair company. They had experimented with replicating a carved sandstone panel from the Houses of Parliament in Ottawa. Using a 3-D scanner, they created a digital map and used an articulating robotic arm, fitted with router bits and cooled with water, to simulate the carved details. The marble pilaster caps were more of a challenge in terms of their detail and wrap-around configuration. They were able to use a variety of bit sizes to reduce the profiled blocks to within 2 mm of the finished surface.

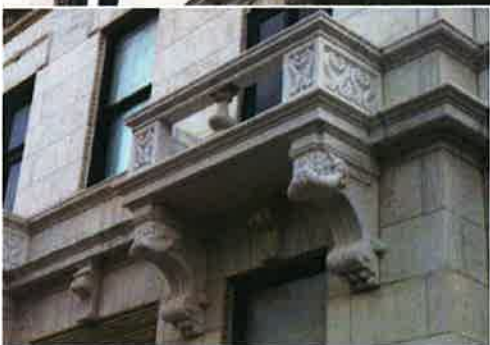
Before and after the restoration of a balcony.

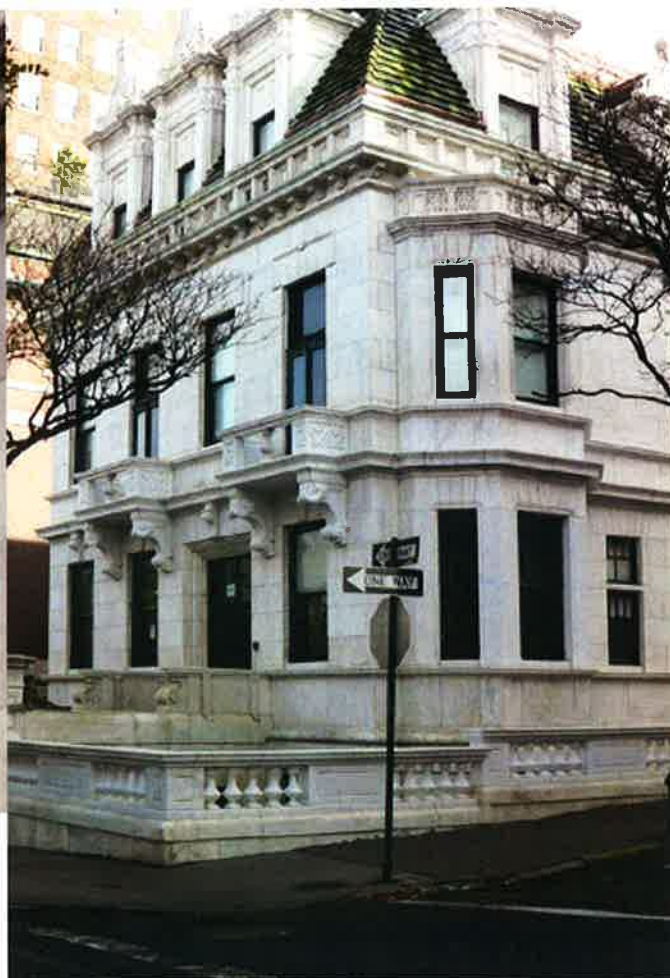
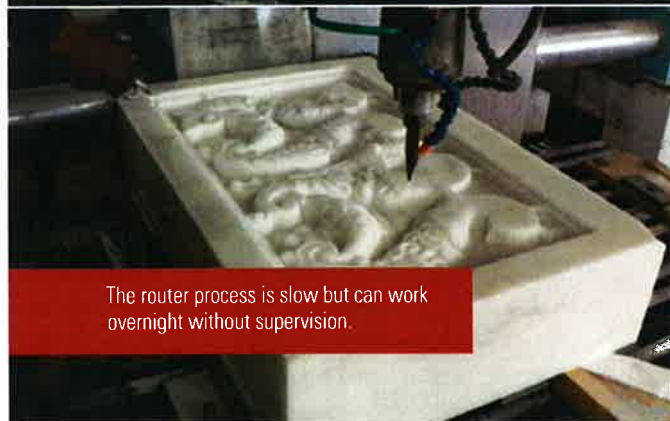
The router process is slow but can work overnight without supervision.

There were four pedestals on the two balconies that featured carved detail. The best example was shipped from the site, and the missing detail was modeled in clay for approval. Once approved, one original was carved. The three remaining pedestals were copied using a simple copying router. The master piece was laid on the left-

side table, and a nylon-tipped pointer scanned the surface at a designated speed, depth and width apart. The new blank stone was laid on the right hand table, and the router bit milled the surface in a similar fashion as a pantograph would work. The router bit was cooled by a stream of re-circulating water, and the slurry was carried away to settle in a holding tank. The process was slow but could work overnight without supervision—no breaks for lunch or coffee either! The milled piece was then carved by hand to create the undercut detail and fine profiles to match the master. The process was limited in size and to flat panel shapes. The equipment sat in the shop for several months before it was implemented for this project.
