The Rockpile

OLD WORLD STONE LTD.

Fall 2006

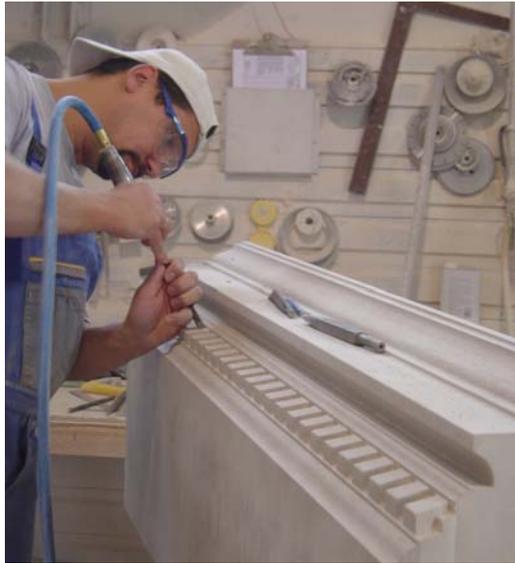
Coach House Restoration Buffalo, NY

Buffalo was booming in the late 1920's when this executive home and coach house were constructed. Phase One of the restoration project includes complete replacement of the coach house copings, parapets and cornices. The original pre-cast concrete material has failed. Moisture penetrated the porous material and caused corrosion and expansion of the internal reinforcing steel. The resulting cracks and fissures accelerated the process of decay and now crumbling concrete poses a potential fall hazard. Old World Stone completed extensive field measurements prior to preparation of detailed shop drawings and templates for the classical detailing. Production is well underway using Indiana buff limestone. US Heritage of Chicago are the masonry consultants.

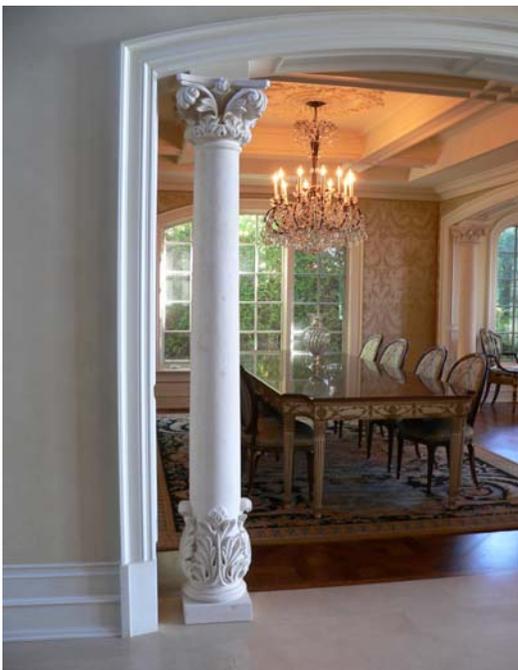
Private Residence, Oakville, Ontario

Cordova limestone from Texas was chosen for interior carved stone details at this custom-built residence. The stone is relatively soft and lends itself easily to carving intricate and flowing detail. Small fossils and inclusions add a special naturalistic appearance and texture to the stone. Our sculptors work from photographs, sketches, or fragments of an original piece. Bring us your ideas.

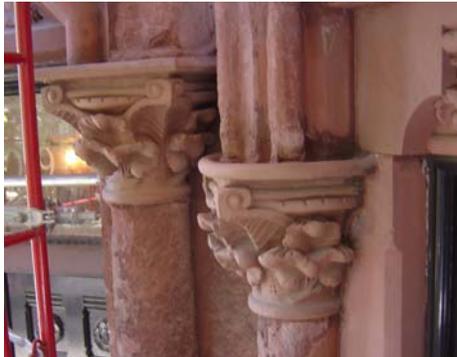
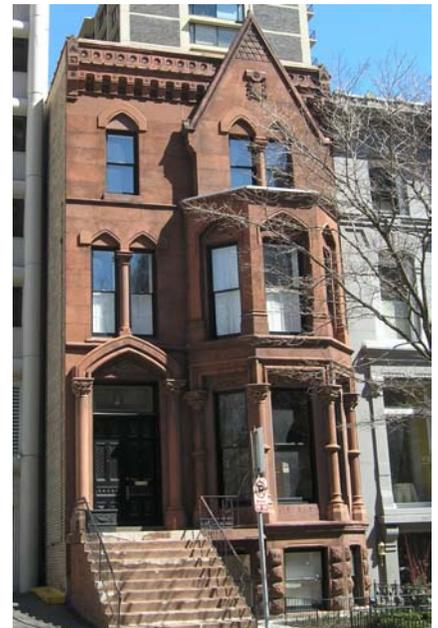
In the Works: Facelift for a Chicago Brownstone

The entire stone façade of this 4 level residence was patched within the last 10 years. The new owners discovered problems of patch delamination and spalling and decided to proceed with the permanent solution of stone replacement. Several options were explored and St. Bees sandstone from Cumbria, England was found to be the most suitable match to the original, in terms of color and texture, and much higher in quality.

Of special interest on this project are the previously patched column capitals and sculpted window lintels, which have to be replaced.

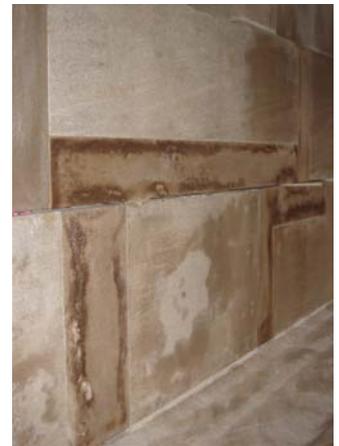
Tools of the Trade - Alkali Staining

Alkali staining is characterized by a brownish-gray or rusty color. Such stains usually occur during or shortly after construction. It is caused by water moving through the assembly and picking up mineral salts and depositing them at the surface of the stone as the water evaporates. Potassium and sodium compounds, which are naturally found in cements, dissolve in water and can leave stains. Unfinished walls or unglazed window openings during construction are likely sources of water infiltration which can lead to staining. The source of the water entry to the building must be resolved first. The stain will disappear on its own in a relatively short time when exposed to natural weathering. Darker stains may take longer. Situations which require more immediate removal can be addressed using dilute trisodium phosphate scrubbed on the surface, followed by low pressure water rinsing. Interior stains can be removed with poultices. For more authoritative information contact the Indiana Limestone Institute of America.

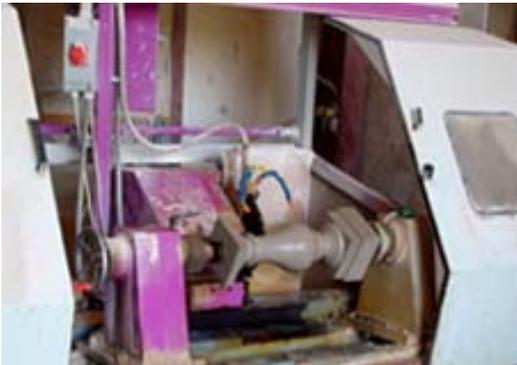
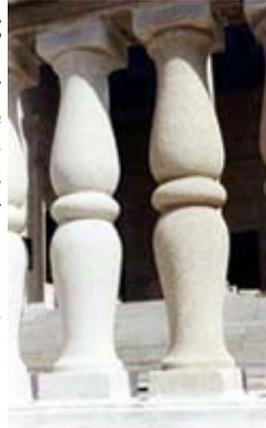
Plant News - The Lathe

Interesting detail may be added to any project with the addition of turned elements such as balusters, columns, finials, urns or spheres. The designer's profile is transferred to a zinc plate, the hydraulic tracing arm of the computerized lathe follows the profile exactly. A spinning block of stone, mounted in front of a rotating, water-cooled

Columns measuring up to 7'-6" in length and 20" in diameter can be turned in one piece with this equipment. Larger drums can be cut on our newest saw, the Lexta.

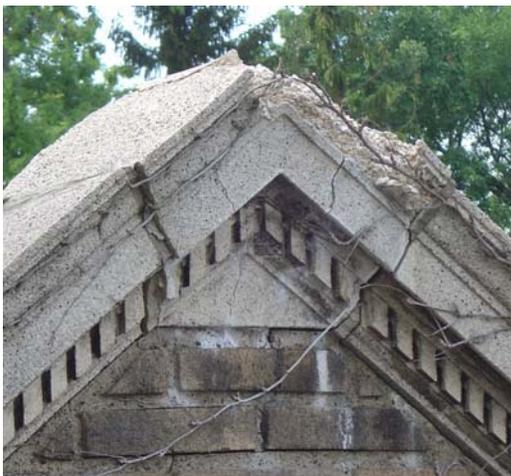
Precast incorporates steel reinforcing, which is susceptible to corrosion. The porous concrete absorbs moisture. In cold climates, cycles of freeze and thaw cause cracking, which allows additional moisture into the assembly and accelerates the rate of decay. Differential expansion and contraction between the steel and the concrete also causes cracking and spalling.

Buffalo coach house original precast.
